Try the un-overlay

Va. tests technology of the unbonded concrete overlay

By Allen Zeyher
Managing Editor

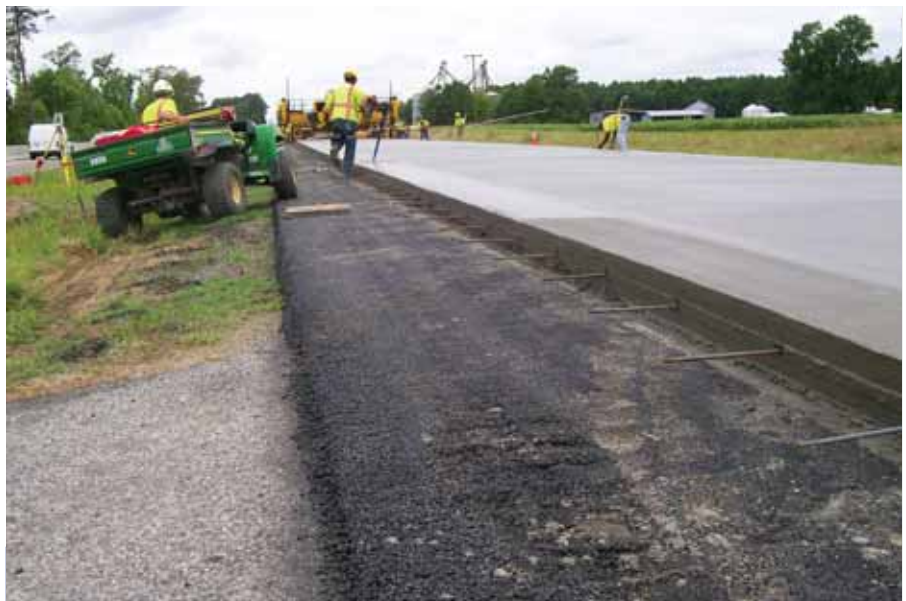
In the unbonded section, they used tie bars to tie the two lanes together and tie the shoulders to the lanes but no reinforcing steel was used.

For the unbonded overlay, VDOT laid a 1-in. layer of a porous friction course asphalt mix over the existing concrete without doing any significant repairs to it. Then they laid 7 in. of concrete over the asphalt.

The asphalt interlayer acts as a bond breaker to separate the overlay from the pavement underneath. It will provide support for the overlay but will not function integrally with it. The second function of the interlayer is to help with drainage.

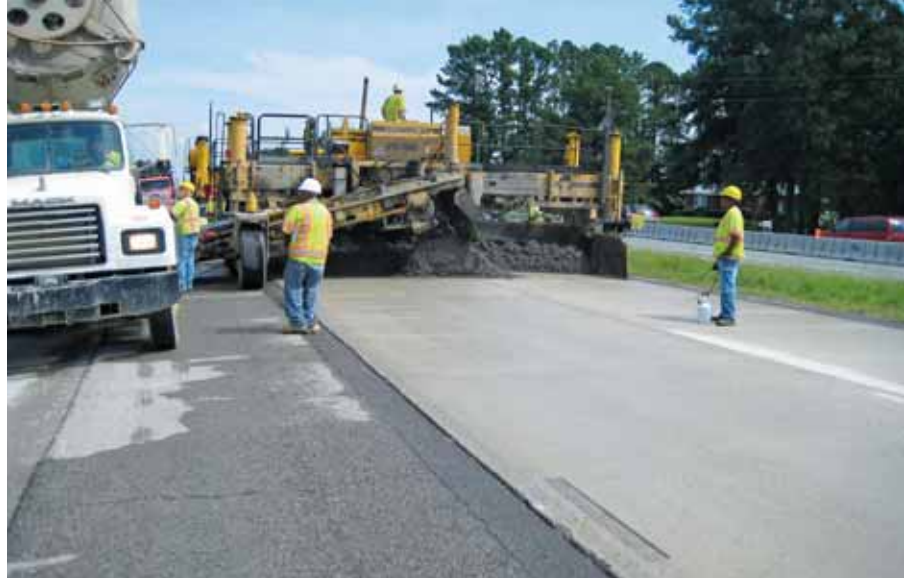
After repairing any broken concrete, the contractor used a stringless, laser-guided system to measure the profile of the old pavement and place the bonded overlay.

Hi-Way Paving used a stringless, laser-guided Leica system and a Gomaco GP 2800 paving machine with a Gomaco belt placer to keep the bonding surface clean. The laser-guided system measured the profile of the existing road down the centerline and every 25 ft out to the edges and constructed a rough 3-D model.

"We built that into our file," Jensen said, "and the paver basically went along and hovered over that existing pavement and filled in the bottom, so to speak."

To form a good bond between the existing pavement and the overlay, Hi-Way Paving first repaired the broken concrete in the existing pavement. Then Shot Blast Inc. of Marcus Hook, Pa., shot-blasted using self-propelled, rideable
